# Fiberscope Inspection Report

James Hardie –Tacoma, Washington – #2 Machine Inspection

10/18/24

Summary of Fiberscope Inspection During 4/24/24

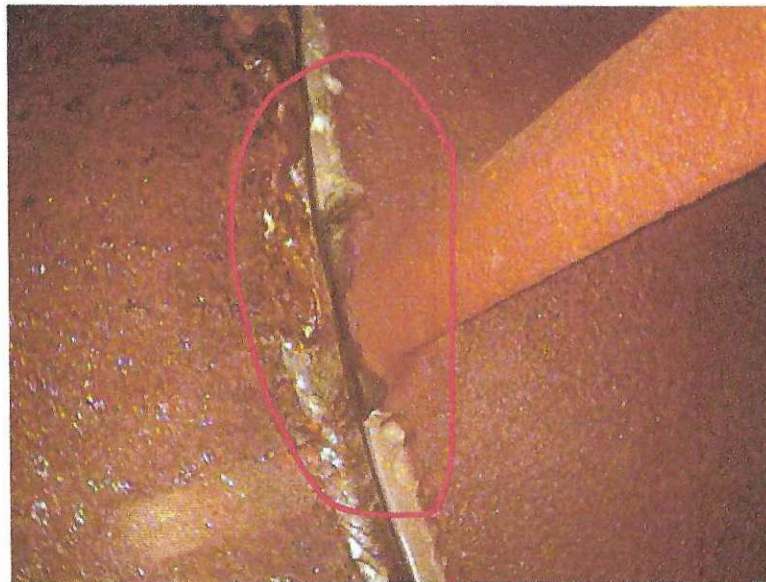
Rotor  
OD  
To  
Body  
ID

Equip#: 213-210-09 Main Vac

Estimated Capacity: 99% Comment: **Unit is like new condition.**

Clearance Rotor OD to Body ID: .029"-.034" (Specs .025"-.035")

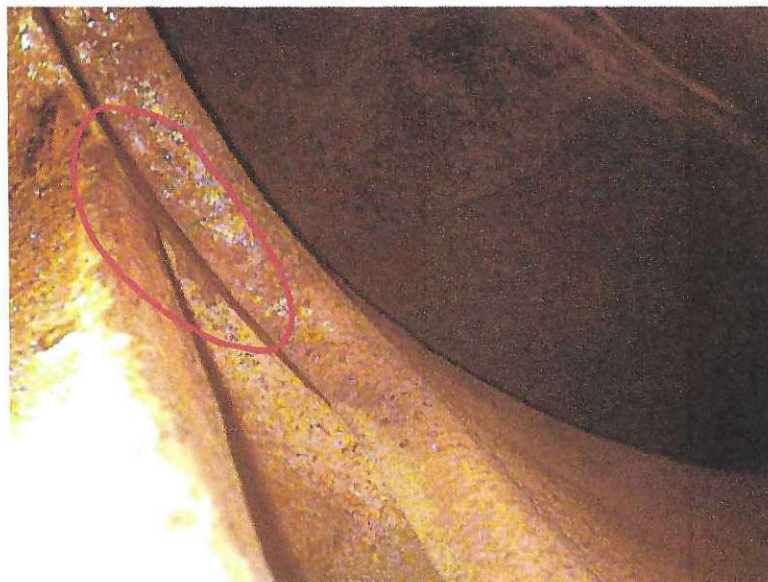
Clearance Rotor Taper to Cone Taper: .039"-.042" (Specs .035"-.045")

Rotor  
Tapers  
Clearance  
Is good

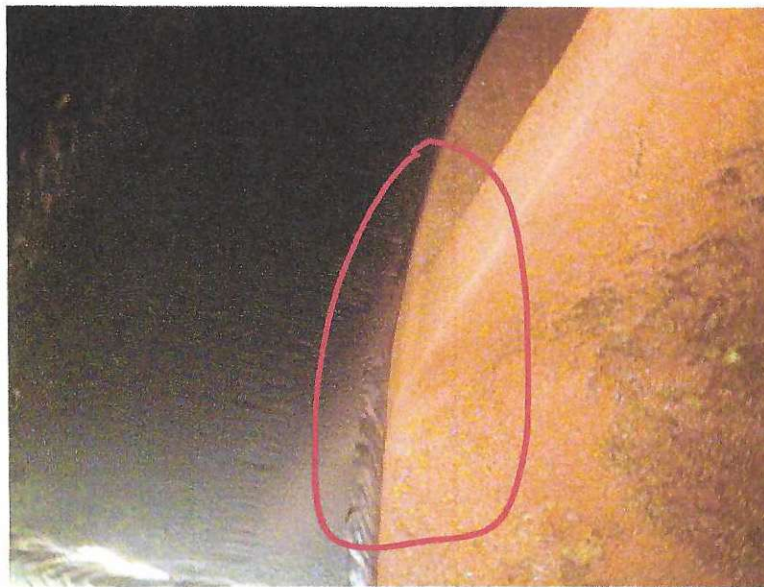
Rotor  
OD  
To  
Body  
ID  
Clearances

Equip#: 213-210-072 H25 Vac

Estimated Capacity: 79% Comment: **Unit is fair condition.**

Clearance Rotor OD to Body ID: **.043"-.047"** (Specs .025"-.035")

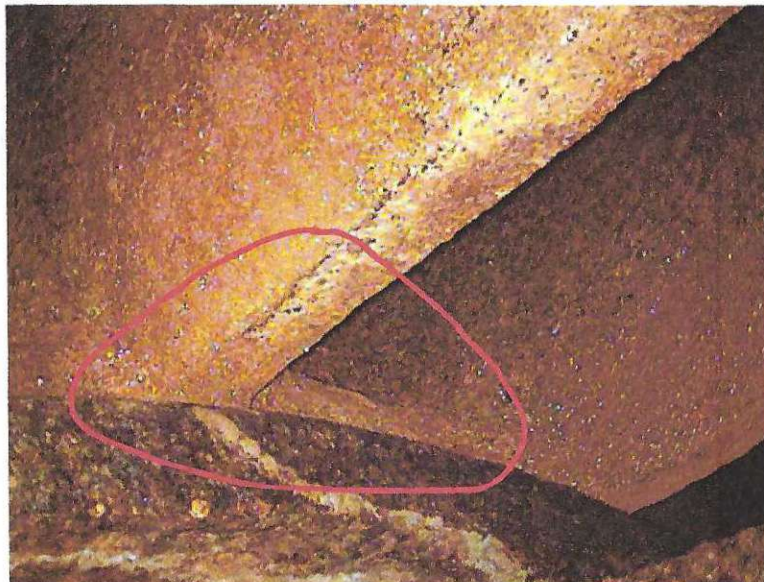
Rotor  
Tapers  
Clearance

Clearance Rotor Taper to Cone Taper: **.041"-.048"** (Specs .035"-.045")

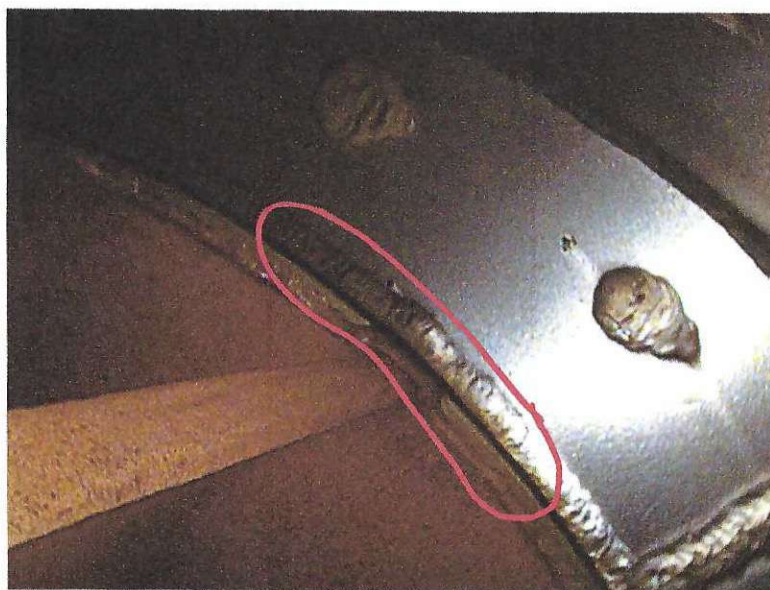
Equip#: 213-210-041 Slice Vac

Estimated Capacity: 91% Comment: **Unit is good condition.**

Clearance Rotor OD to Body ID: **.038"-.042"** (Specs .025"-.035")

Rotor  
OD  
To  
Body  
ID  
Clearances  
are good

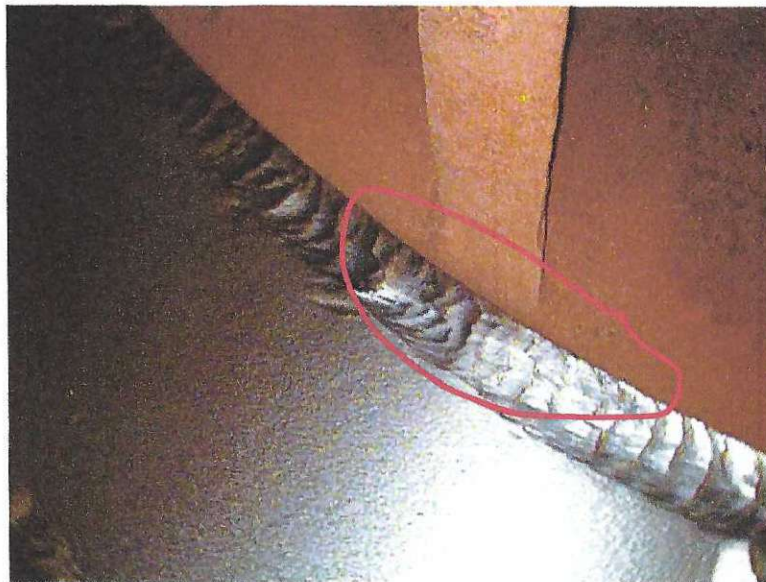
Equip#: 213-210-012 Inner Tub Vac

Estimated Capacity: 96% Comment: **Unit is near new condition.**

Clearance Rotor OD to Body ID: .027"-.036" (Specs .025"-.035")

Rotor  
OD  
To  
Body  
ID  
Clearances  
are very good

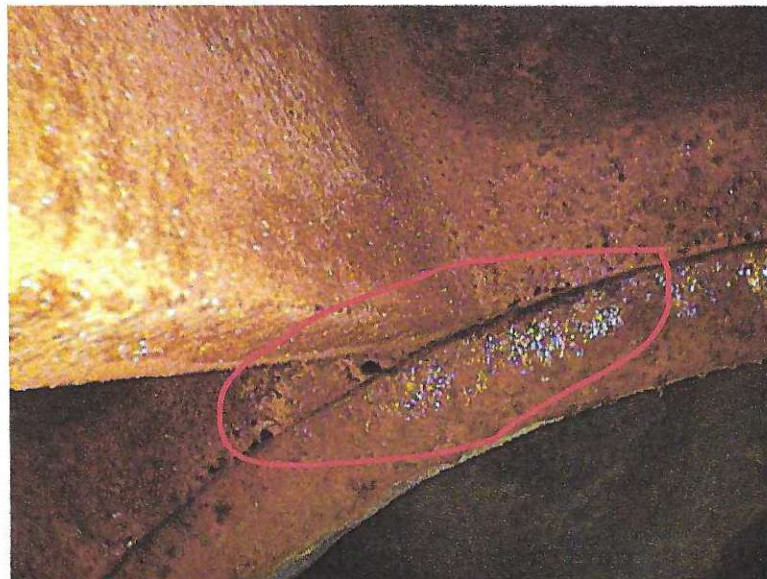
Clearance Rotor Taper to Cone Taper: .036"-.041" (Specs .035"-.045")

Rotor  
Tapers  
Clearance  
are very good
