Procter & Gamble
800 N Rice Ave
Oxnard, CA 93030

Reference; Inspection 7/29/2024

Thank you for the opportunity to assist you in the inspection of your #1X Paper Machine vacuum performance. My inspection was done with the motors locked out and lowering a digital boroscope down through each pump, visually inspecting all critical dimensions.

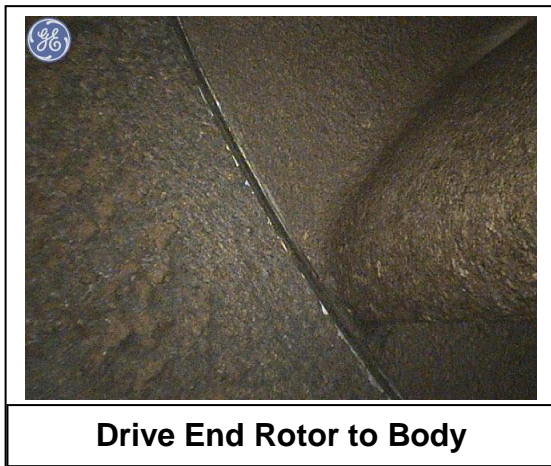
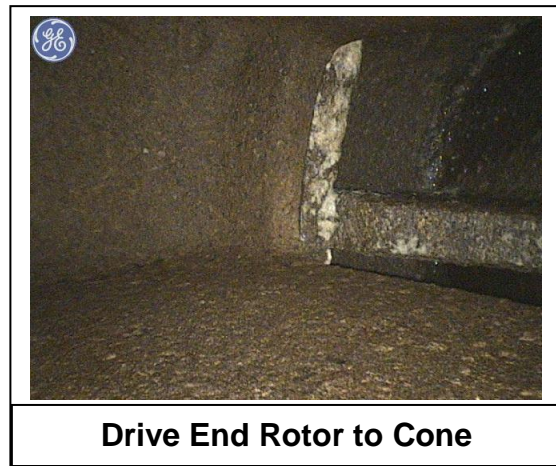
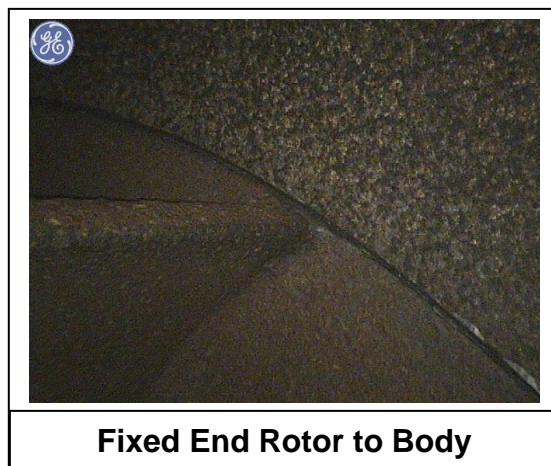
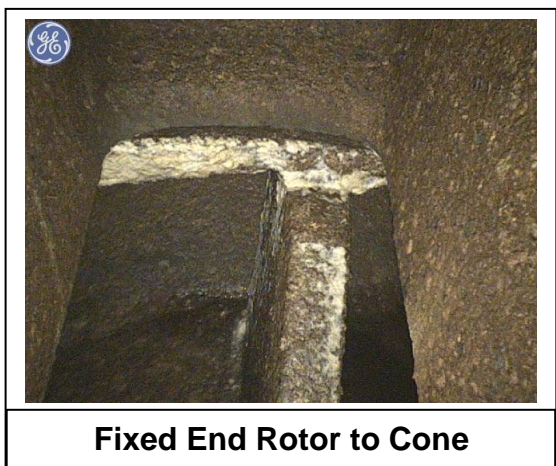
Body is clean and smooth. Rotor OD and body shroud are standard.

Rotor has light scale. Rotor blades are well rounded from carry over. Rotor taper to cone clearance is standard.

Cones show normal wear with light stock deposits in inlet ports.
